Facilities Case Study: Granborough St John the Baptist

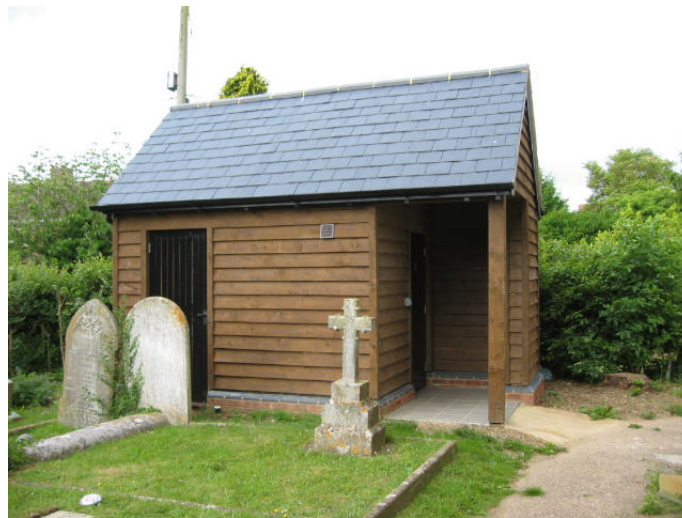
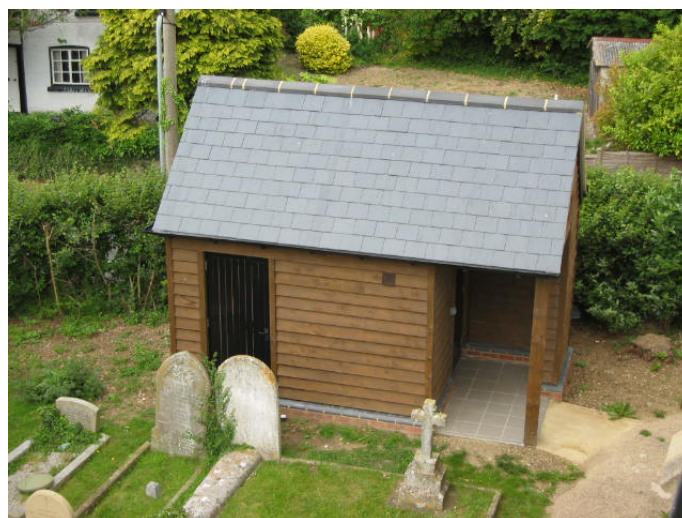
A galley kitchen comprising of cupboards, a sink, mixer tap and drainage board was installed along the north wall of the ground floor of the tower, with the advantages of retaining more space, plus the keeping access from the west door free. Solid oak floor and wall units were selected along with a stone worktop for longevity, and, importantly, the units were fitted to a frame of vertical wooden battens with a ventilation gap between the units, floor and the wall, so as to prevent damp penetrating the units.

While the servery needed to be inside the church for practical reasons, it was decided that the WC should be located in a small, architect-designed stand-alone building a few metres away north of the tower, affording level access for disabled/frail users. The building was constructed in stained timber and weatherboarding, with a tile floor, sheltered lobby (for carers of the disabled or people queuing to use) leading to a disabled WC, with a separate store on the end with its own door. In this case, the use of timber was an economical alternative to stone, and was preferable because it helps the building to be read as ancillary and subservient to the church, while the slate roof is hard-wearing and in keeping with many of the roofs in the village.
