## **Facilities Case Study: Granborough St John the Baptist**

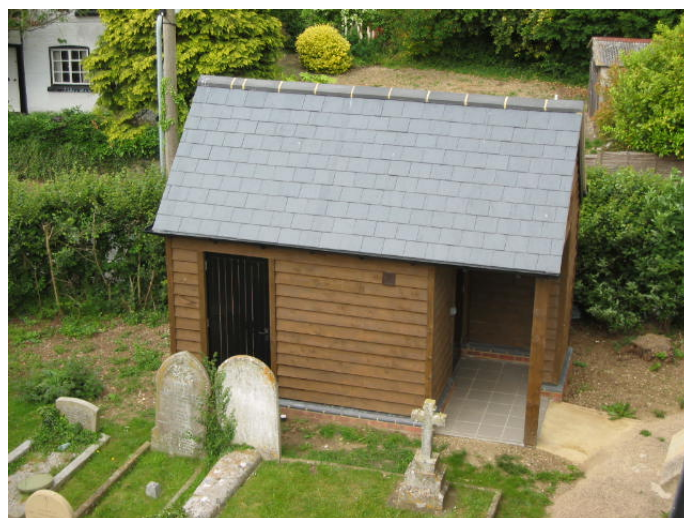
While the servery needed to be inside the church for practical reasons, it was decided that the WC should be located in a small, architect-designed stand-alone building a few metres away north of the tower, affording level access for disabled/frail users. The building was constructed in stained timber and weatherboarding, with a tile floor, sheltered lobby (for carers of the disabled or people queuing to use) leading to a disabled WC, with a separate store on the end with its own door. In this case, the use of timber was an economical alternative to stone, and was preferable because it helps the building to be read as ancillary and subservient to the church, while the slate roof is hard-wearing and in keeping with many of the roofs in the village.
